Manhole Inspection Summary

Manhole # S33AA_028MH

Insp Date: **7/7/08 1:30 PM**

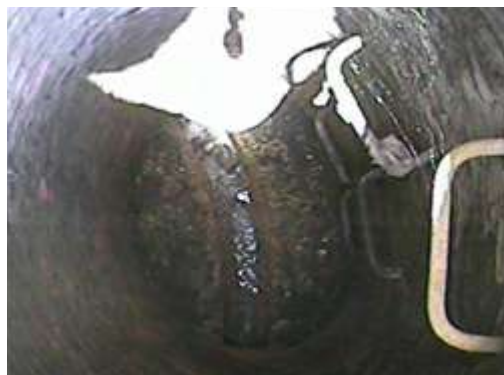
Top View

DEBRIS ON BENCH

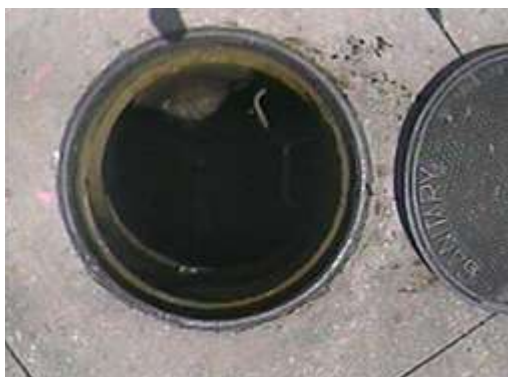
Top View

Frame Offset: **1** (in.) Condition: ☒ Sound ☐ Cracked ☐ Leaks

FRAME OFFSET

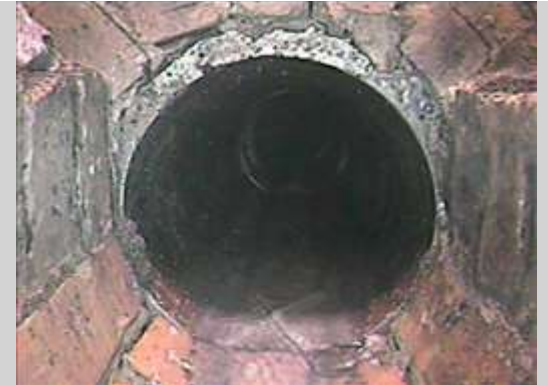
12 O'Clock Outflow

8 in. Circular Gravity Sewer
Pipe Out @ 12 O'Clock

Infiltration: **None** Pipe Seal Cond: **Sound**

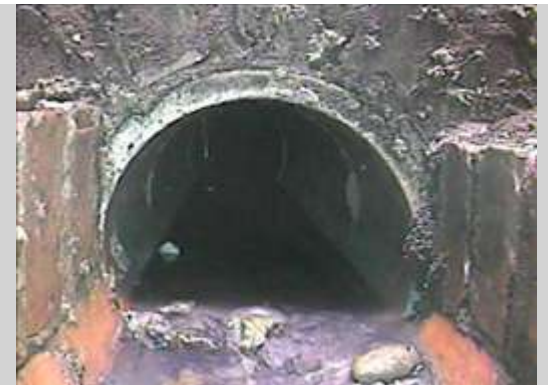
5 O'Clock Inflow

8 in. Circular Gravity Sewer
Pipe In @ 5 O'Clock

Infiltration: **None** Pipe Seal Cond: **Sound**
